WRDC-TR-90-3078

**AN EXPERIMENTAL EVALUATION OF THE IMPACT RESISTANCE OF
RECOATED F-16A MONOLITHIC POLYCARBONATE FLAT SHEET**

Michael P. Bouchard
University of Dayton Research Institute
Dayton, Ohio 45469-0110

Interim Report for Period October 1984-March 1989

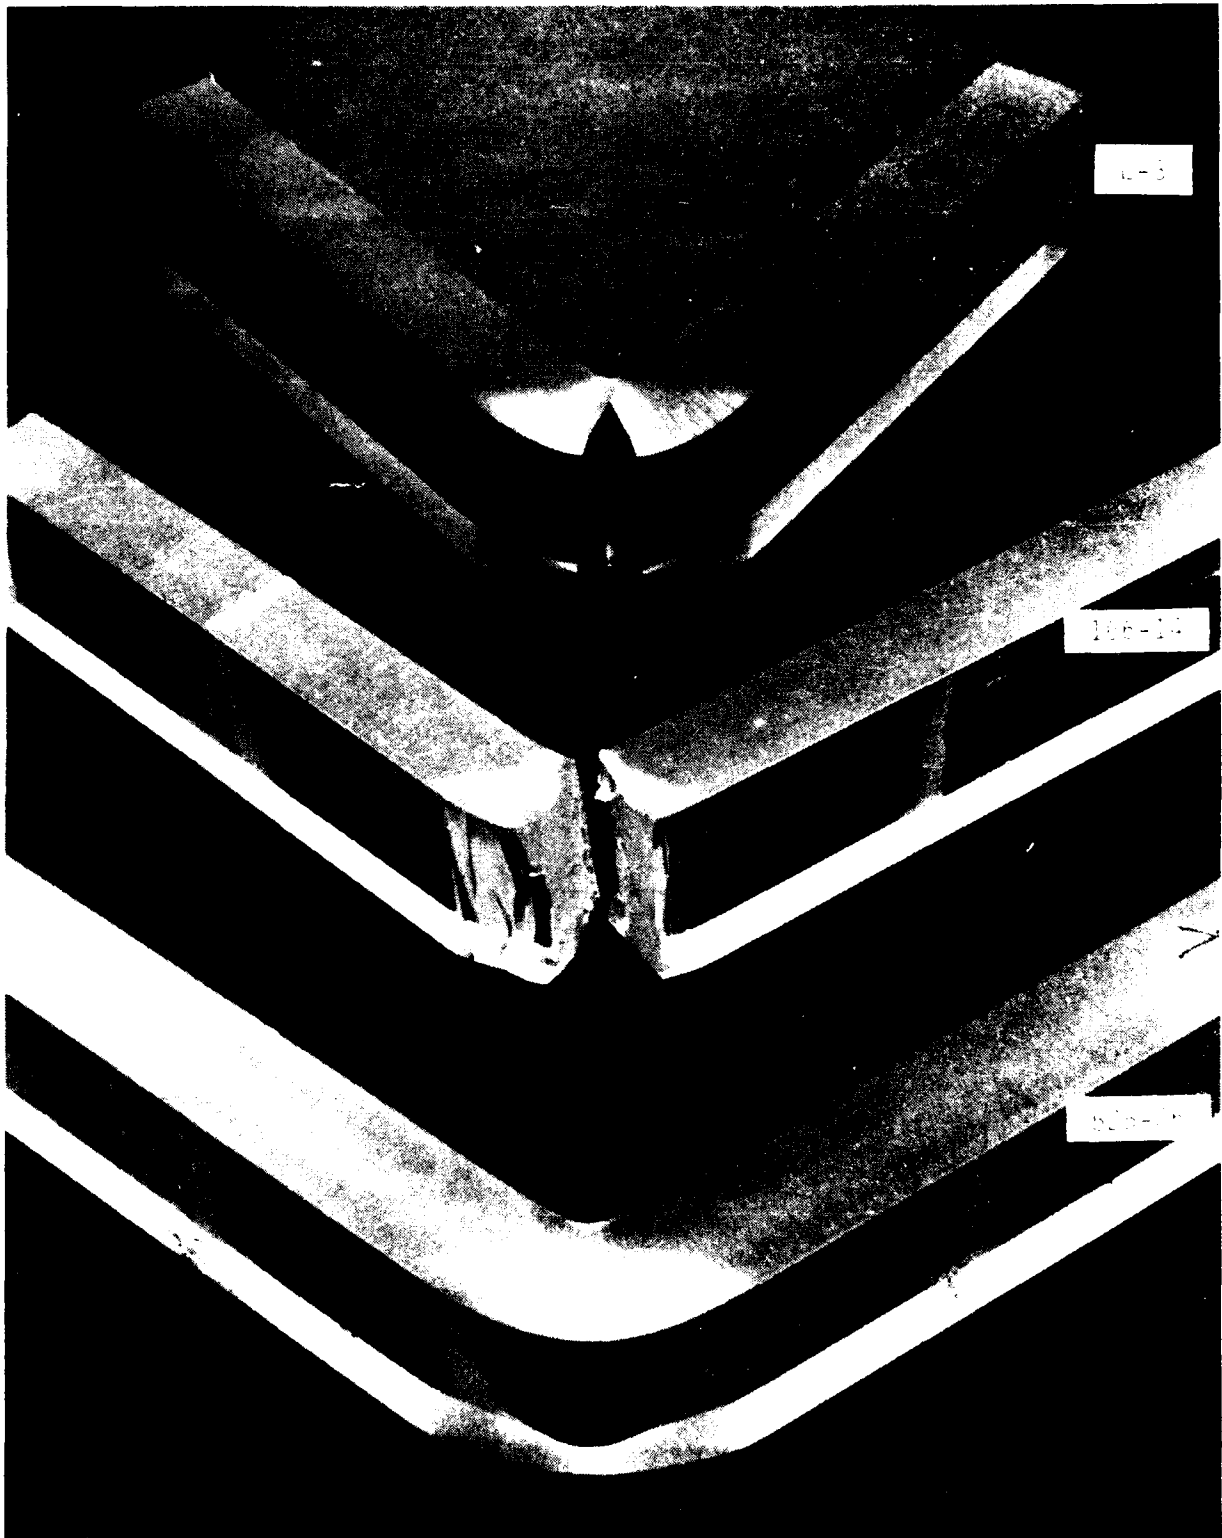
Figure 3.9. Typical Failure Modes for the laminates.

Figures 3.8 and 3.9 present failure modes for the flat sheet and canopy beams, respectively. The baseline stripped (B) and Lexan (L) baseline beams showed excellent ductile deformation, although the Lexan beams cracked deeply for unknown reasons. The newly coated (A) and recoated (M and 166) beams showed little permanent deformation prior to fracture into two pieces. The beams with the original coating and subsequent QUV weathering (I) or service life (525) showed excellent ductile deformation. All of the QUV beams (G, H, and I) showed excellent ductility, although the G beams all fractured into two pieces, two of the H beams fractured into two pieces, and only one of the I beams fractured into two pieces. None of the canopy 525 beams fractured into two pieces. Yield lines in the coatings of the flat sheet and canopy beams were similar. The newly coated beams had coarsely-spaced transverse yield lines which penetrated deep into the polycarbonate substrate as a result of testing. With increasing service life or QUV weathering, the lines became more closely spaced and shallow, giving a hazy appearance to the test surface. For the 2 and 3-year flat-sheet beams with the original coating and QUV weathering (H and I) and the canopy beams with the original coating and service life (525), the coating adhesion was reduced significantly, so that the yield lines did not penetrate the polycarbonate substrate and the coating was easily removed by scratching by a fingernail. In summary, the failure modes of both the flat sheet and canopy beams (1) compared favorably, (2) indicated that increasing QUV weathering or service life resulted in increased ductile deformation during testing, and (3) indicated reduced coating adhesion with increasing QUV weathering or service life.
